PERIODIC REVIEW

**Union Station
Facility Site ID#: 2060**

**Jackson Street and Fourth Avenue Vicinity,
Seattle, Washington**

January 2010

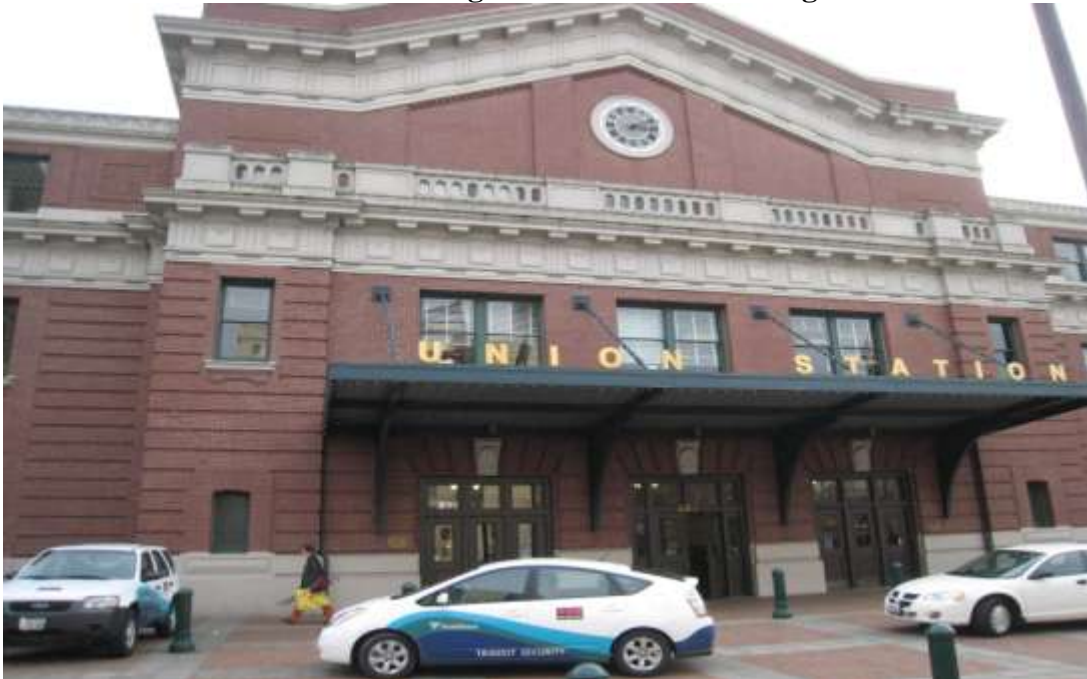
Photo 1: Front of Union Station Buildings - from Jackson looking south

Based upon the site visit conducted on January 27, 2010, the remedy at the Site continues to eliminate exposure to contaminated soils by ingestion and contact. The asphalt, pavement and other surface cover appears in satisfactory condition and no repair, maintenance, or contingency actions have been required. The Site is still operating as a large city block of various activities including a bus tunnel portal. A photo log is available as Appendix 6.5.
